The Hanneys Flood Group Report

Environment Agency conservation officers
visit to Letcombe Brook at East Hanney.

22nd May 2008

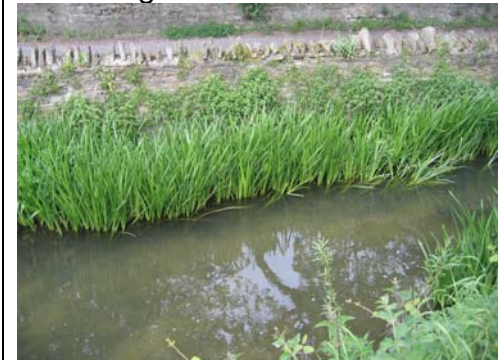
| Observations | Agreed Actions |
|---|---|
| <p data-bbox="225 264 927 338">Large amount of Sparganium (Bur Reed) restricting main channel</p> | <p data-bbox="927 264 1369 526">May be cut back, but ensure to leave a fringe to reduce erosion of the bank and highway footings. Also note that the restricted channel in this area results in faster flow and hence less silting.</p> |

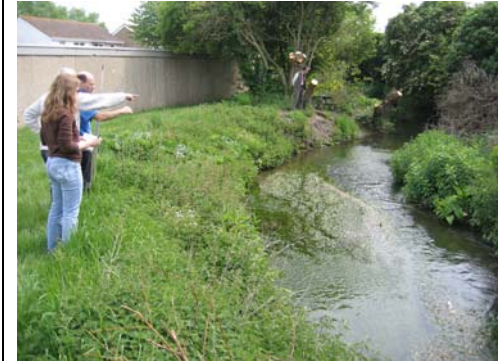
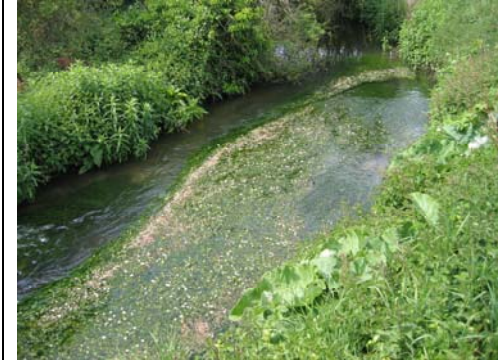
| Observations | Agreed Actions |
|---|---|
| <p data-bbox="225 696 927 734">Brookside Area</p> <p data-bbox="225 734 927 884">Large clumps of Ranunculus in channel. The presence of this species is a strong indication of good water quality, but the quantity currently in the channel is reducing water flow</p> | <p data-bbox="927 696 1369 996">Action can be taken to reduce the amount of Ranunculus in the channel by removing sufficient material to reduce a clump to around a third of the channel and positioned in the centre section.</p> |

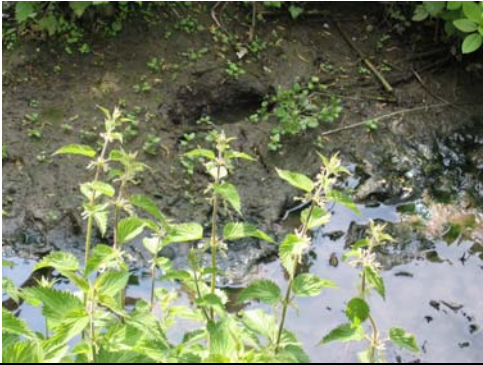
| Observations | Agreed Actions |
|---|---|
| <p>Evidence of cress.</p> | <p>Leave undisturbed</p> |

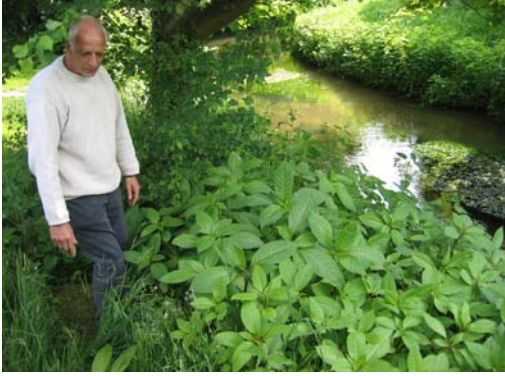
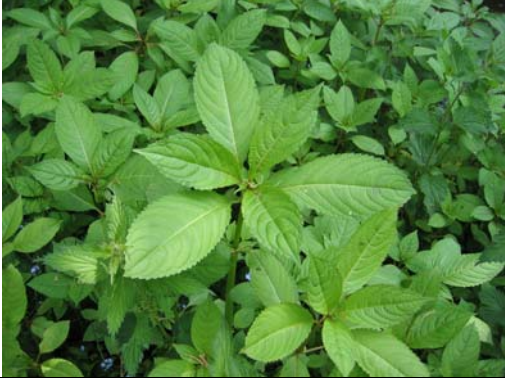
| Observations | Agreed Actions |
|---|---|
| <p>Clumps of Himalayan Balsam, a highly invasive plant, identified</p> | <p>Should be completely removed without delay, as they will spread significant amounts of seeds if left to flower.</p> |

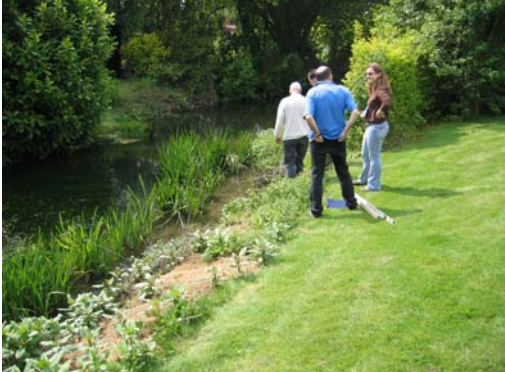
| Observations | Agreed Actions |
|---|---|
| <p>Grass clippings found deposited on bank. These create a toxic mixture when wet, killing river wildlife.</p> | <p>Education required, as clippings should be disposed of away from the river – ideally composted. The area would benefit from local planting of indigenous wild plants. A Fetter can give guidance</p> |

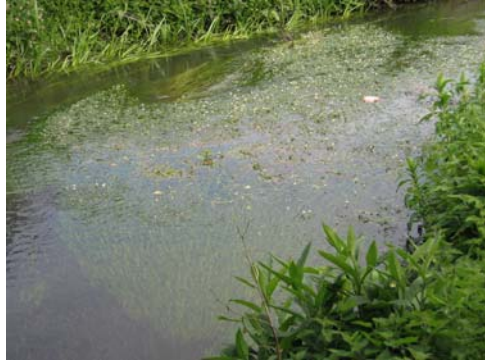
| Observations | Agreed Actions |
|--|---|
| <p data-bbox="225 230 496 264">Iron Bridge Area</p> <p data-bbox="225 264 874 450">Large clumps of Ranunculus in channel. The presence of this species is a strong indication of good water quality, but the quantity currently in the channel is reducing water flow</p> | <p data-bbox="874 230 1369 600">Action can be taken to reduce the amount of this species in the channel by removing sufficient material to reduce a clump to around a third of the channel and positioned in the centre section. Following sections should try to encourage a sinuous route where practicable.</p> |

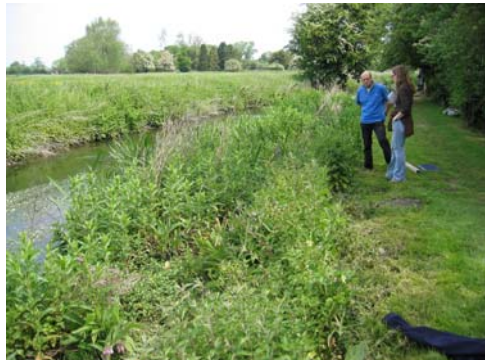
| Observations | Agreed Actions |
|--|---|
| <p data-bbox="225 846 459 880">Low Bank Area</p> <p data-bbox="225 880 874 992">The group acknowledged that the east bank was very low and overflows regularly even after moderate rainfalls.</p> | <p data-bbox="874 846 1369 1294">The EA Representatives suggested that the best course of action would be for a formal request to be made to them, whereupon suggestions, drawings and options could be considered. It was also noted that the EA recommended that the large silted area containing willow herb vegetation should form an integral part of the banking plan</p> |

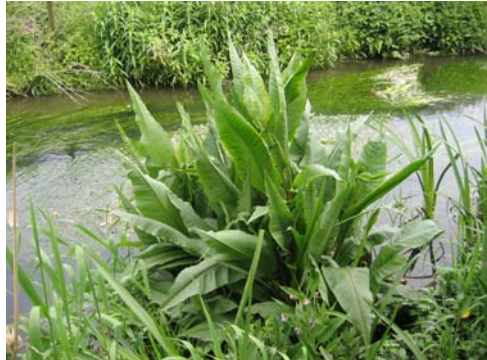
| Observations | Agreed Actions |
|---|--|
| <p>An excellent example of a Rumex Water Dock was observed in this stretch of the brook</p> | <p>Please do not disturb!</p> |

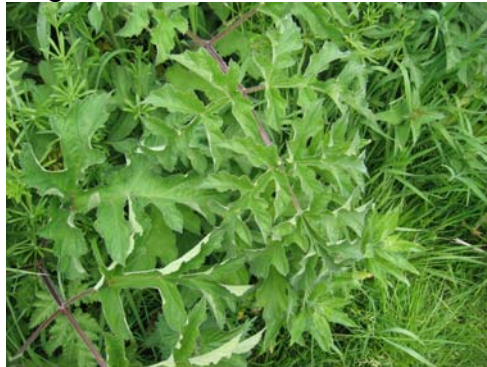
| Observations | Agreed Actions |
|---|--|
| <p>Hog Weed Observed</p> | <p>Should be removed with caution, as this variety can cause skin irritation</p> |

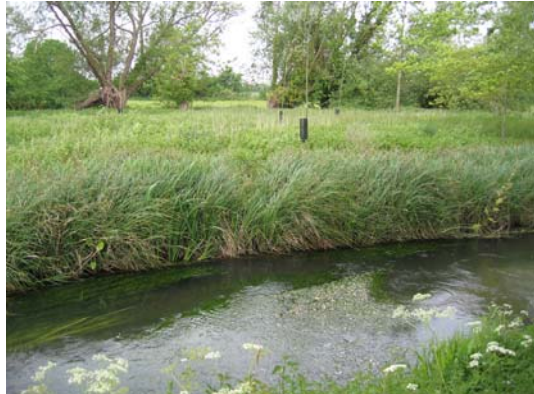
| Observations | Agreed Actions |
|---|--|
| <p>The abundance of Ranunculus and silt in the channel at this point is particularly dense.</p> | <p>It was agreed that a second channel could be made, producing an island in the middle section of the channel</p> |

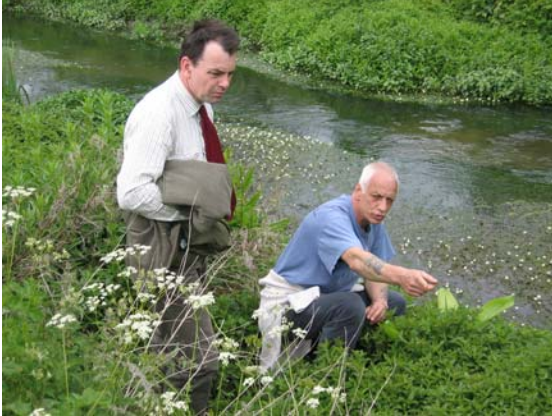
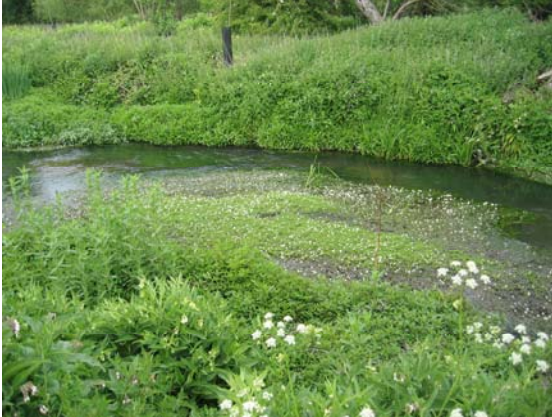
| Observations | Agreed Actions |
|---|---|
| <p>Lower Mill Area</p> <p>The EA representatives considered this stretch “outstanding”. It offers a perfect habitat for water voles, although none have been recorded recently. The sedges are particularly good examples of what is achievable.</p> | <p>Action can be taken to reduce the amount of Ranunculus in the channel by removing sufficient material to reduce a clump to around a third of the channel and positioned in the centre section.</p> |
